Reston Community Center Terry L. Smith Aquatics Center

Preliminary Assessment

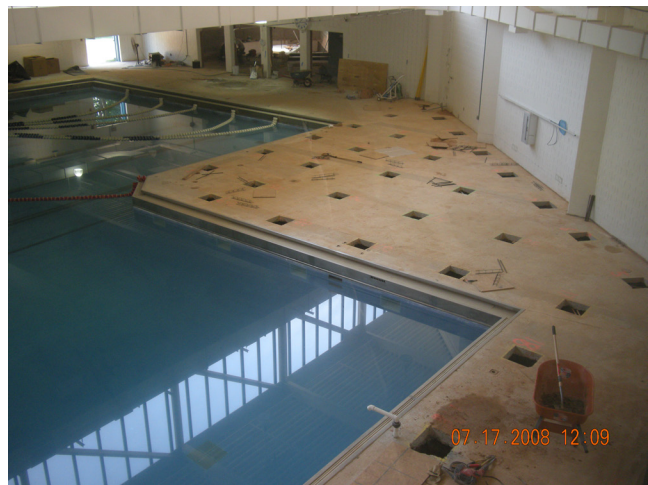
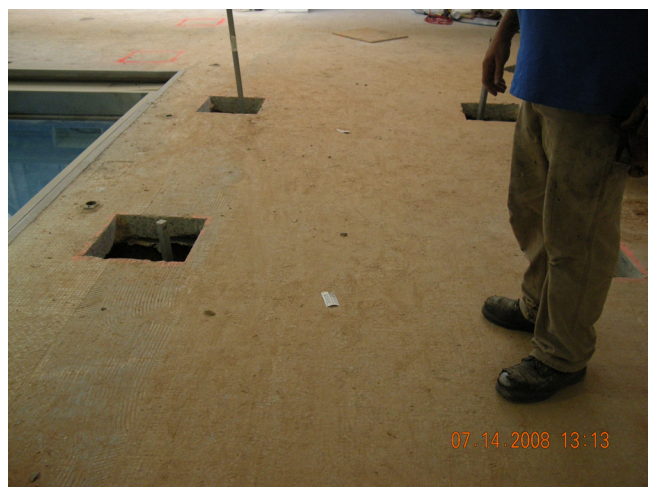
A surge tank (approx. 4,000 gallons) is located under the pool deck adjacent to the northwest pool wall. The surge tank has deteriorated and needs to be replaced.

A sanitary sewer structure located on the south

building exterior has deteriorated and needs to be replaced.
